SUBJECT Road Bridge over Peene River
5X1A near Wolgast

Following is data on the almost completed road bridge over the Peene River near WOLCAST (N 55/P 92) (western branch of the Oder River mouth), supplementing reference reports.

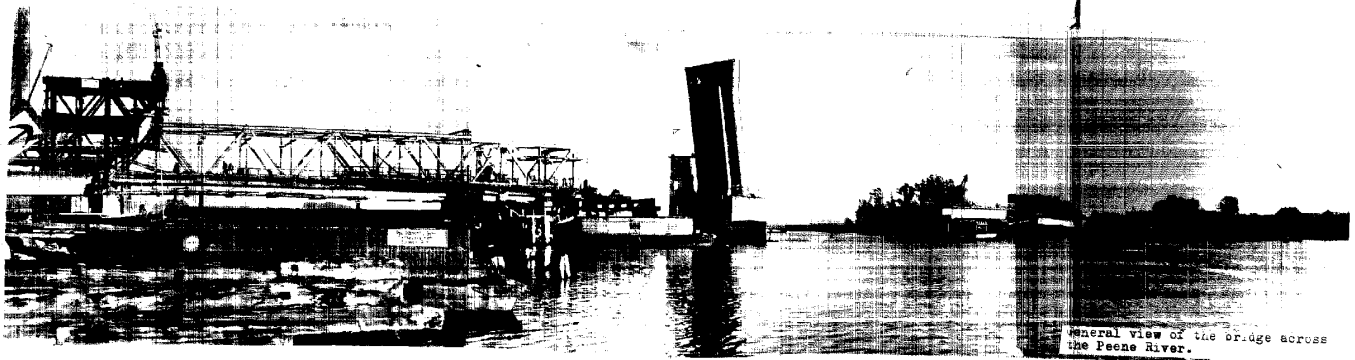
General view of the bridge across the Peene River.

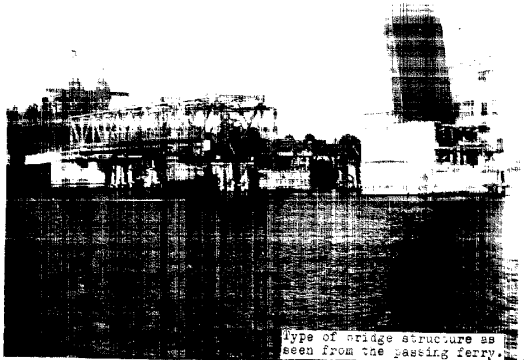
6. Type of construction: Permanent structure, concrete piers and abutments, steel superstructure, middle section a drawbridge. Five piers, six spans of 40 meters each; drawbridge section, 50 meters. The piers are not protected by ice aprons. Roadway and approaches are paved, but the approaches need repair.

Type of bridge structure as seen from the passing ferry.

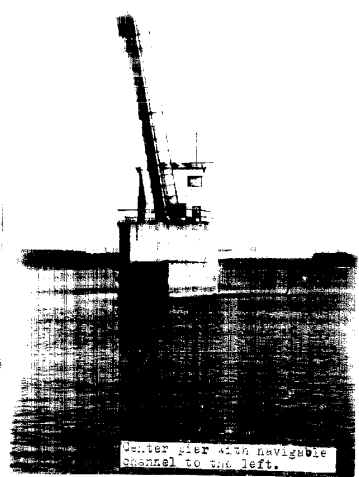
Center pier with navigable channel to the left.
